Pond Information							
Pond ID:	BF-8	Pond Type:	Biofiltration Device				
Location:	Bradley Road Median						
Subdivision:		Watershed:	MI-29				
Capacity:		Acres:					
Overflow Elev:		100 Year Elev:					
Year Constructed:		Date Input:					
Water Quality:		Private:					
Inspection Details							
Inspector Name(s):	Mark Bruns						
Inspection Date:	10/30/2019	Start Time:	1535	End Time:	1550		
Weather Condition:	43 Degrees, Cloudy			Last Rainfall Date:	10/27/2019		
Issue	Checked			Maintenance Needed			Comments
	Y	N	N/A	Y	N	N/A	
Dry Pond

Proprietary Device System Checklist

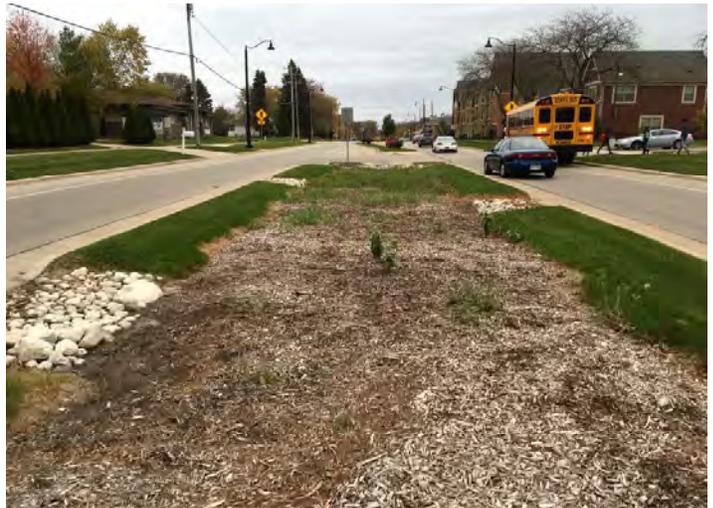
BF-7 Inspection, 10/30/2019

Issue	Checked			Maintenance Needed			Comments
	Y	N	N/A	Y	N	N/A	
Vegetation							
1. Adequate vegetation cover?	Y			Y			Thin vegetation at the east curb cut-outs.

2. Appropriate vegetation?	Y			Y			Thistles and weeds are present.
3. Presence of invasive or undesirable vegetation/woody growth?	Y			Y			Thistles and weeds are present.

10. Other?	Y			Y			Sediment accumulation on the rip-rap at the curb inlets.

5. Graffiti removal needed?	Y				N		
6. Insects in excess?	Y				N		
7. Public hazards?	Y				N		
8. Other?			N/A			N/A	
Summary:	This device is in the median and appears to be functioning as designed. There are thistles and weeds that should be removed. There is sediment in the rip-rap at the curb inlets that should be removed.						
Inspector Remarks:

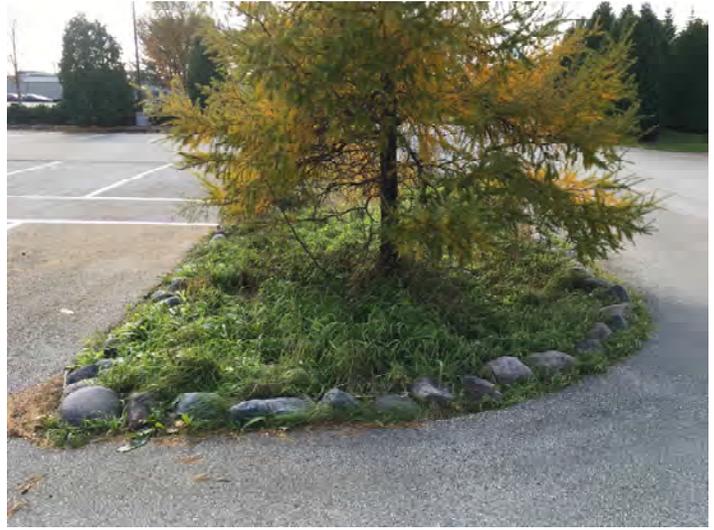
BF-10A Inspection, 11/05/2019

6. Insects in excess?			N/A			N/A	
7. Public hazards?			N/A			N/A	
8. Other?			Y			Y	Garbage should be removed.
Summary:	Garbage and weeds should be removed. No standing water. The device appears to be functioning.						
Inspector Remarks:

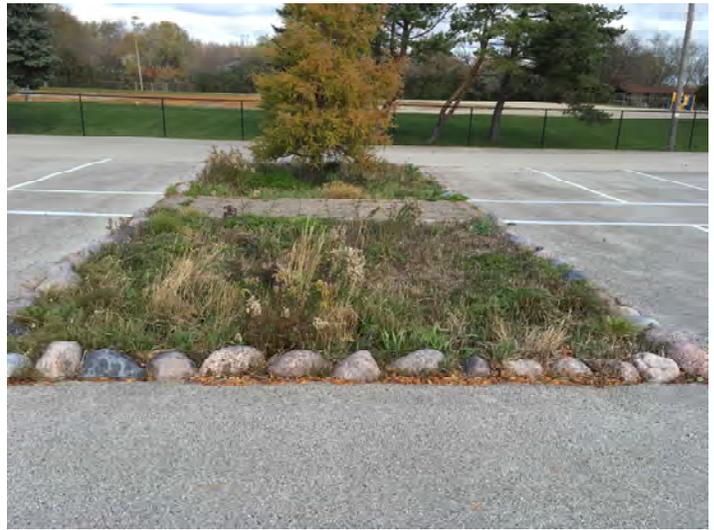
BF-10C Inspection, 11/05/2019

6. Insects in excess?			N/A			N/A	
7. Public hazards?			N/A			N/A	
8. Other?			Y			Y	Garbage should be removed.
Summary:	Garbage and weeds should be removed. No standing water. The device appears to be functioning.						
Inspector Remarks:
