Crime Bulletin

Skimming Devices

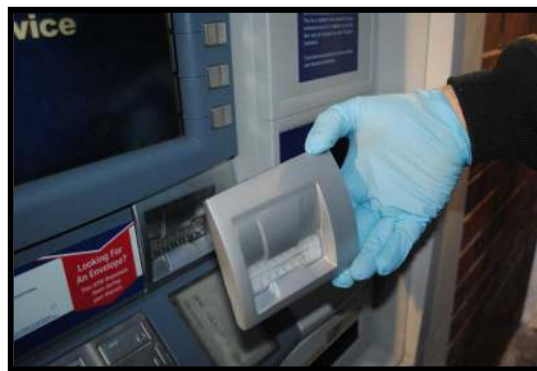
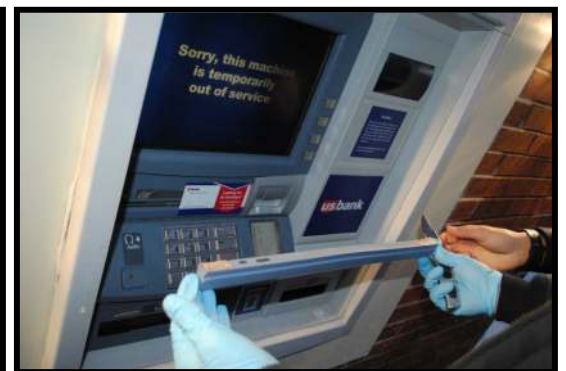
Employees had notified law enforcement that a "skimmer" device had been placed on an ATM. Investigating officers discovered a skimmer insert that had been placed over the card reader. Also located was a blue bar that sat on top of the machine that contained a pinhole camera. This camera recorded pin numbers that were punched into the keypad.

A technician from the ATM manufacturer explained that the way he could tell that the ATM machine had been compromised was that the card reader did not light up when a card was inserted. He also noted that the blue bar containing the pinhole camera was colored a slightly lighter blue than the screen. The technician believes the skimmer was put on the machine at a particular time which is when the machine began to document "bad insert reads" on the diagnostics.

Beware of any alterations to an ATM and notify employees and law enforcement if you suspect anything out of the ordinary.
