Pond Information							
Pond ID:	BF-8	Pond Type:	Biofiltration Device				
Location:	Bradley Road Median						
Subdivision:		Watershed:	MI-29				
Capacity:		Acres:					
Overflow Elev:		100 Year Elev:					
Year Constructed:		Date Input:					
Water Quality:		Private:					
Inspection Details							
Inspector Name(s):	Mark Bruns						
Inspection Date:	10/30/2019	Start Time:	1535	End Time:	1550		
Weather Condition:	43 Degrees, Cloudy			Last Rainfall Date:	10/27/2019		
Issue	Checked			Maintenance Needed			Comments
	Y	N	N/A	Y	N	N/A	
Dry Pond

Proprietary Device System Checklist

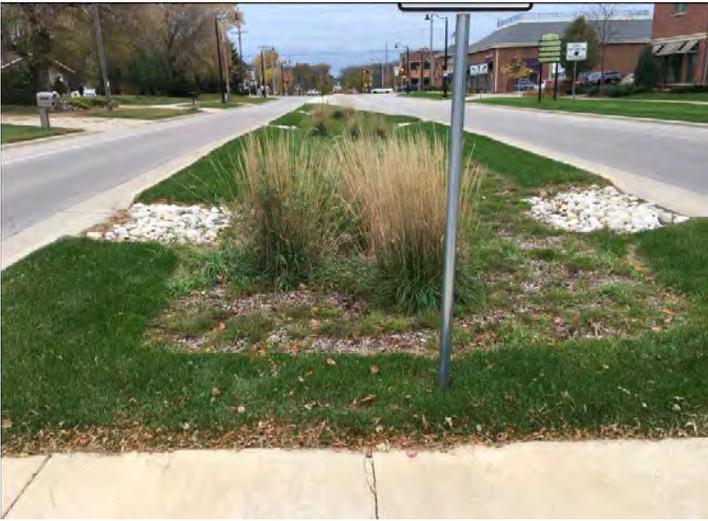
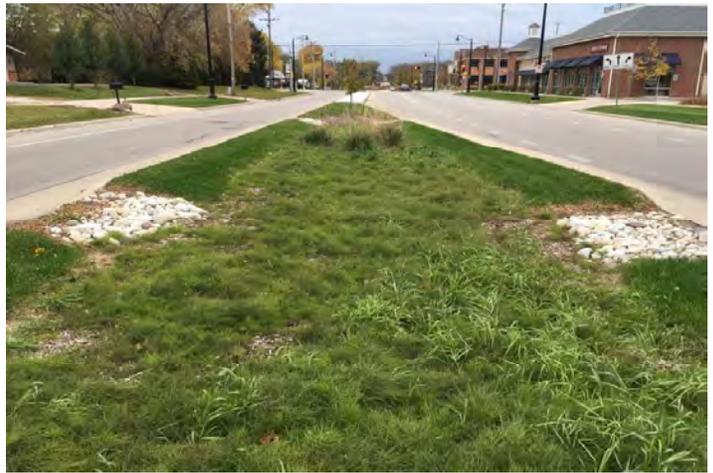
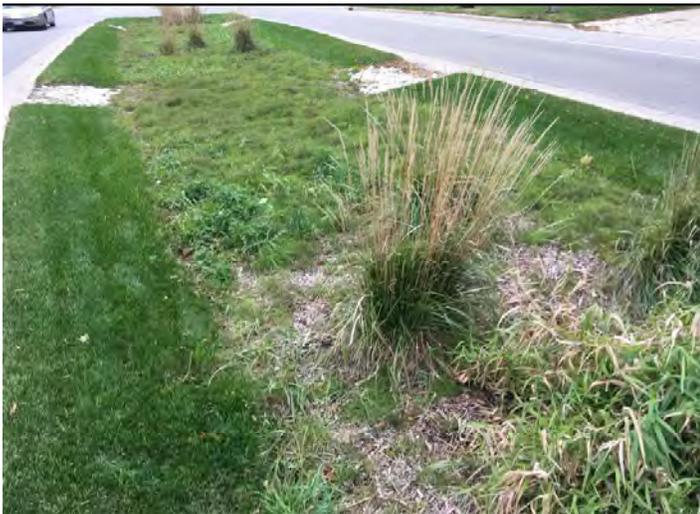
BF-9 Inspection, 10/30/2019

6. Insects in excess?	Y			N			
7. Public hazards?	Y			N			
8. Other?	N/A			N/A			
Summary:	This device appears to be functioning as designed. There are thistles, weeds, and woody growth that should be removed. There is trash within the device that should be removed. There is also sediment accumulation that should be removed from the stone inlet at the northwest corner of the device.						
Inspector Remarks:	Continue to mow and maintain per maintenance agreement.

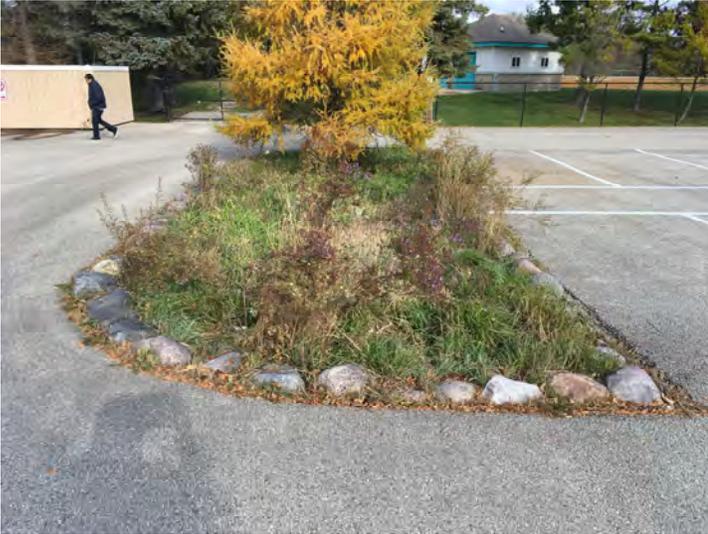
BF-10A Inspection, 11/05/2019

6. Insects in excess?			N/A			N/A	
7. Public hazards?			N/A			N/A	
8. Other?			Y			Y	Garbage should be removed.
Summary:	Garbage and weeds should be removed. No standing water. The device appears to be functioning.						
Inspector Remarks:

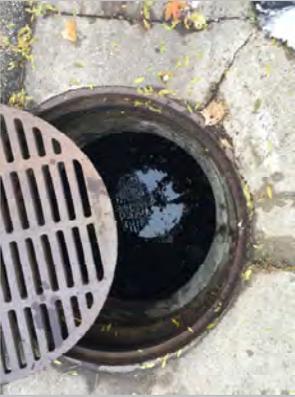
PD-06 Inlet, 11/01/2019

Comments: No sheen or debris is present.

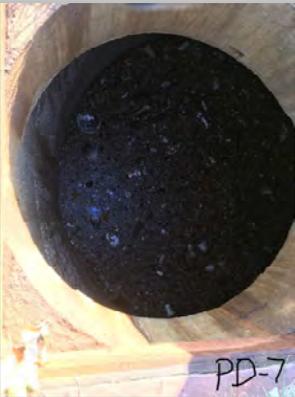
PD-07 East, 11/05/2019

Inspector Name(s): Mark Bruns		Weather Conditions: 37 Degrees, Mostly Sunny				
Inspection Date: 11/05/2019		Location: 49th & Schroeder; PD-07 East				
Type of Inspection	Drainage System Feature	Problem	Conditions to Check For	Recommended Action	Maintenance Needed (Yes/No)	Comments
Inspections are performed in accordance with the maintenance agreement or owners recommendation	Settling Chamber	Sediment accumulation	Sediment capacity reached (varies depending on the model, see attached table)	Sediment should be removed using vactor truck	<input type="radio"/> N/A <input type="radio"/> Yes <input checked="" type="radio"/> No	No sediment.
	Settling Chamber	Trash and floatable debris accumulation	Excessive trash and floatable debris accumulation.	Remove trash or other floatable debris.	<input type="radio"/> N/A <input checked="" type="radio"/> Yes <input type="radio"/> No	Garbage and debris are present.

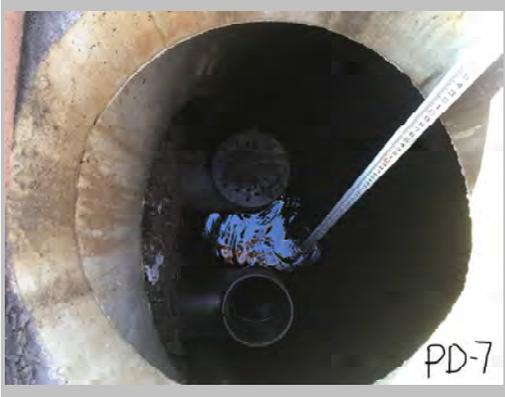
PD-07 West, 11/05/2019

Inspector Name(s): Mark Bruns		Weather Conditions: 37 Degrees, Mostly Sunny				
Inspection Date: 11/05/2019		Location: 49th & Schroeder; PD-07 West				
Type of Inspection	Drainage System Feature	Problem	Conditions to Check For	Recommended Action	Maintenance Needed (Yes/No)	Comments
Inspections are performed in accordance with the maintenance agreement or owners recommendation	Settling Chamber	Sediment accumulation	Sediment capacity reached (varies depending on the model, see attached table)	Sediment should be removed using vactor truck	<input type="radio"/> N/A <input type="radio"/> Yes <input checked="" type="radio"/> No	0.5 feet of sediment.
	Settling Chamber	Trash and floatable debris accumulation	Excessive trash and floatable debris accumulation.	Remove trash or other floatable debris.	<input type="radio"/> N/A <input checked="" type="radio"/> Yes <input type="radio"/> No	Leaves present in trash rack.

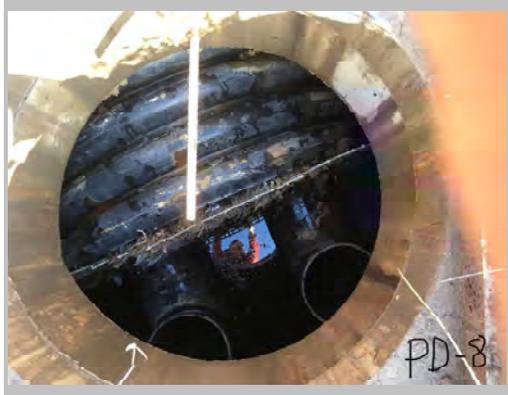
Comments: No unusual odor, sheen, or floatables are present.

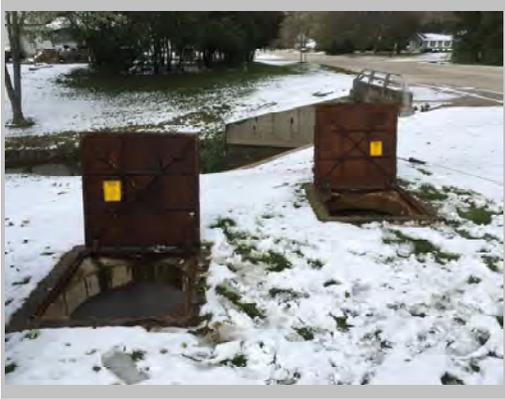
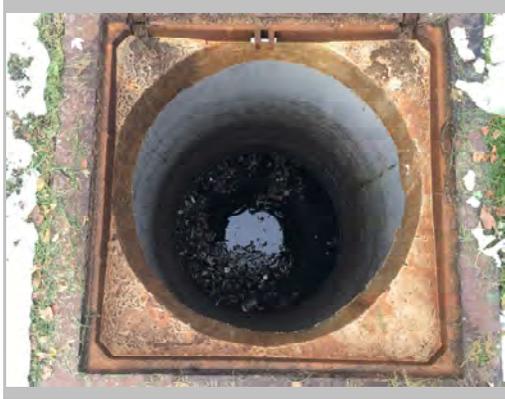
PD-09 North, 11-05-2019

Inspector Name(s): Mark Bruns			Weather Conditions: 32 Degrees, Cloudy			
Inspection Date: 11/01/2019			Location: 51st & Beaver Creek; PD-09 North			
Type of Inspection	Drainage System Feature	Problem	Conditions to Check For	Recommended Action	Maintenance Needed (Yes/No)	Comments
Inspections are performed in accordance with the maintenance agreement or owners recommendation	Settling Chamber	Sediment accumulation	Sediment capacity reached (varies depending on the model, see attached table)	Sediment should be removed using vactor truck	<input type="radio"/> N/A <input type="radio"/> Yes <input checked="" type="radio"/> No	0.3 feet of sediment.
	Settling Chamber	Trash and floatable debris accumulation	Excessive trash and floatable debris accumulation.	Remove trash or other floatable debris.	<input type="radio"/> N/A <input checked="" type="radio"/> Yes <input type="radio"/> No	Some floating debris is present.

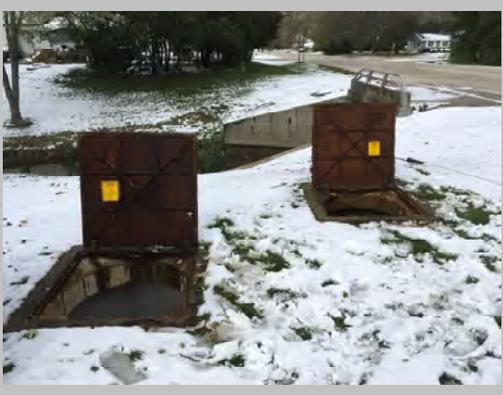
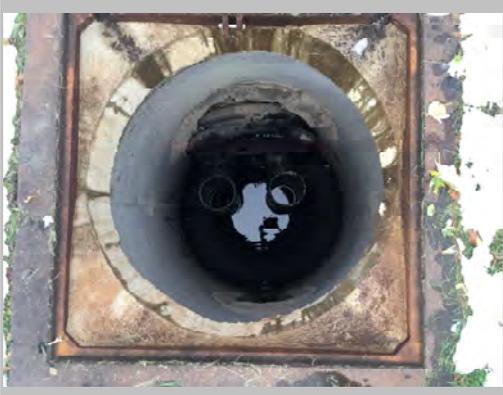
PD-09 South (Inlet), 11-05-2019

Comments: No unusual odor, sheen, or debris is present.

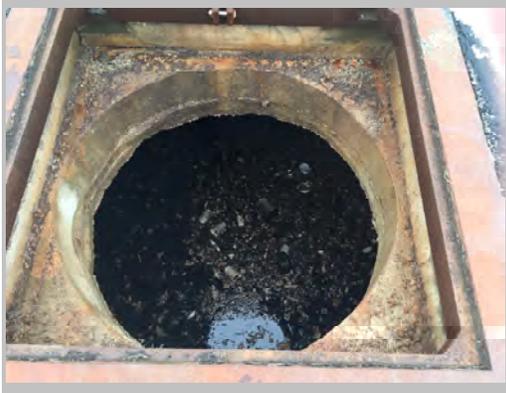
PD-10 North, 11/01/2019

Inspector Name(s): Mark Bruns		Weather Conditions: 28 Degrees, Mostly Cloudy				
Inspection Date: 11/01/2019		Location: Greenbrook & Arbon; PD-10 North				
Type of Inspection	Drainage System Feature	Problem	Conditions to Check For	Recommended Action	Maintenance Needed (Yes/No)	Comments
Inspections are performed in accordance with the maintenance agreement or owners recommendation	Settling Chamber	Sediment accumulation	Sediment capacity reached (varies depending on the model, see attached table)	Sediment should be removed using vactor truck	<input type="radio"/> N/A <input type="radio"/> Yes <input checked="" type="radio"/> No	1 foot of sediment.
	Settling Chamber	Trash and floatable debris accumulation	Excessive trash and floatable debris accumulation.	Remove trash or other floatable debris.	<input type="radio"/> N/A <input checked="" type="radio"/> Yes <input type="radio"/> No	Floating debris is present.

Comments: No apparent sheen or unusual odor is present.

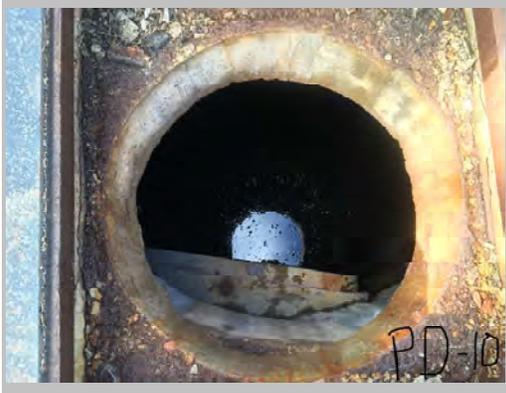
PD-10 South, 11/01/2019

Comments: No apparent sheen or unusual odor.

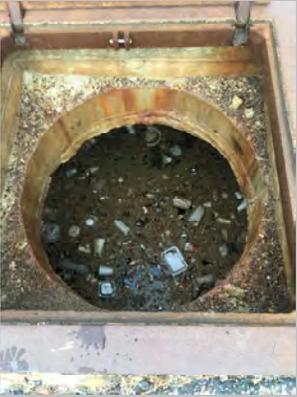
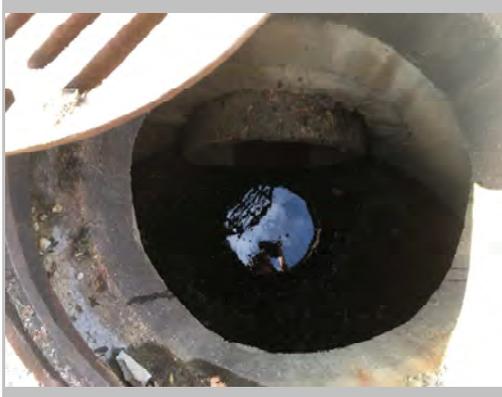
PD-11, 11/01/2019

Inspector Name(s): Mark Bruns		Weather Conditions: 28 Degrees, Mostly Cloudy				
Inspection Date: 11/01/2019		Location: 51st & Greenbrook; PD-11				
Type of Inspection	Drainage System Feature	Problem	Conditions to Check For	Recommended Action	Maintenance Needed (Yes/No)	Comments
Inspections are performed in accordance with the maintenance agreement or owners recommendation	Settling Chamber	Sediment accumulation	Sediment capacity reached (varies depending on the model, see attached table)	Sediment should be removed using vactor truck	<input type="radio"/> N/A <input type="radio"/> Yes <input checked="" type="radio"/> No	1 foot of sediment.
	Settling Chamber	Trash and floatable debris accumulation	Excessive trash and floatable debris accumulation.	Remove trash or other floatable debris.	<input type="radio"/> N/A <input checked="" type="radio"/> Yes <input type="radio"/> No	Floating debris is present.

Comments: No apparent sheen or unusual odor is present.

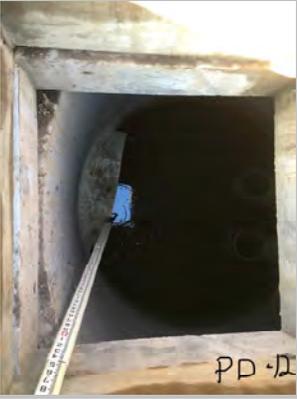
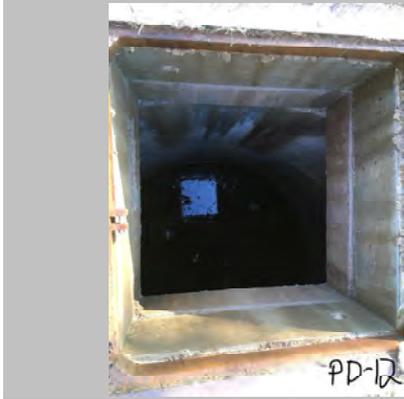
PD-12 East, 11/05/2019

Comments: No sheen, unusual odor, or floating debris is present.

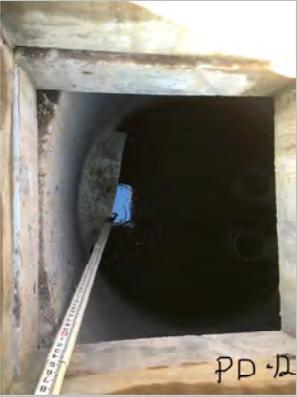
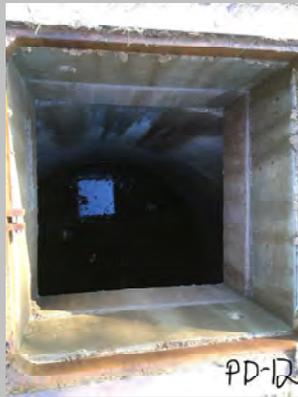
PD-12 West, 11/05/2019

Comments: No sheen, unusual odor, or floating debris is present.

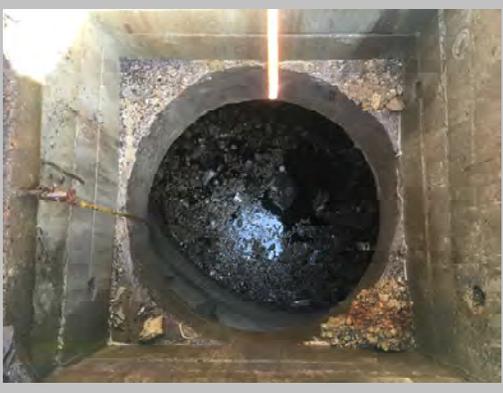
PD-13 East, 11/05/2019

Inspector Name(s): Mark Bruns				Weather Conditions: 36 Degrees, Partly Cloudy		
Inspection Date: 11/05/2019				Location: Behind Wal-Mart; PD-13 East		
Type of Inspection	Drainage System Feature	Problem	Conditions to Check For	Recommended Action	Maintenance Needed (Yes/No)	Comments
Inspections are performed in accordance with the maintenance agreement or owners recommendation	Settling Chamber	Sediment accumulation	Sediment capacity reached (varies depending on the model, see attached table)	Sediment should be removed using vactor truck	<input type="radio"/> N/A <input type="radio"/> Yes <input checked="" type="radio"/> No	0.5 foot of sediment.
	Settling Chamber	Trash and floatable debris accumulation	Excessive trash and floatable debris accumulation.	Remove trash or other floatable debris.	<input type="radio"/> N/A <input checked="" type="radio"/> Yes <input type="radio"/> No	Heavy amount of trash is present.

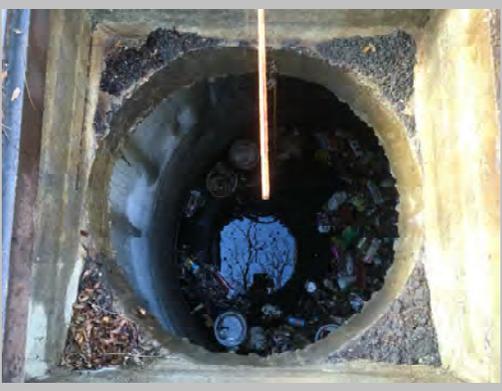
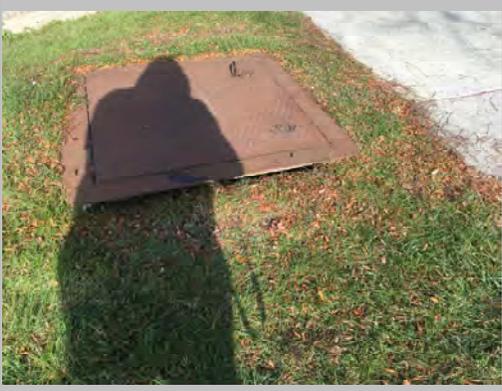
PD-14 East, 11/05/2019

Inspector Name(s): Mark Bruns		Weather Conditions: 34 Degrees, Partly Cloudy				
Inspection Date: 11/05/2019		Location: 60th & Silverbrook; PD-14 East				
Type of Inspection	Drainage System Feature	Problem	Conditions to Check For	Recommended Action	Maintenance Needed (Yes/No)	Comments
Inspections are performed in accordance with the maintenance agreement or owners recommendation	Settling Chamber	Sediment accumulation	Sediment capacity reached (varies depending on the model, see attached table)	Sediment should be removed using vactor truck	<input type="radio"/> N/A <input checked="" type="radio"/> Yes <input type="radio"/> No	2.5 feet of sediment.
	Settling Chamber	Trash and floatable debris accumulation	Excessive trash and floatable debris accumulation.	Remove trash or other floatable debris.	<input type="radio"/> N/A <input checked="" type="radio"/> Yes <input type="radio"/> No	Trash and floating debris are present.

Comments: Slight odor, trash and debris are present. The boom is discolored.

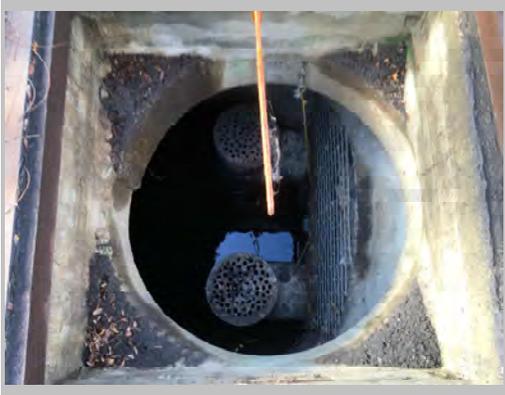
PD-14 West, 11/05/2019

Inspector Name(s): Mark Bruns		Weather Conditions: 34 Degrees, Partly Cloudy				
Inspection Date: 11/05/2019		Location: 60th & Silverbrook; PD-14 West				
Type of Inspection	Drainage System Feature	Problem	Conditions to Check For	Recommended Action	Maintenance Needed (Yes/No)	Comments
Inspections are performed in accordance with the maintenance agreement or owners recommendation	Settling Chamber	Sediment accumulation	Sediment capacity reached (varies depending on the model, see attached table)	Sediment should be removed using vactor truck	<input type="radio"/> N/A <input checked="" type="radio"/> Yes <input type="radio"/> No	2.4 feet of sediment.
	Settling Chamber	Trash and floatable debris accumulation	Excessive trash and floatable debris accumulation.	Remove trash or other floatable debris.	<input type="radio"/> N/A <input checked="" type="radio"/> Yes <input type="radio"/> No	Trash and debris are present.

Comments: There is a gap in the frame.

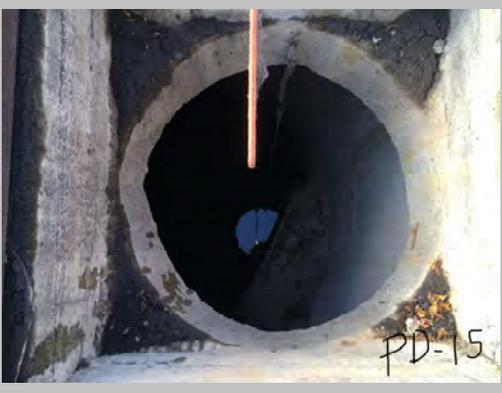
PD-15 East, 11/05/2019

Comments: Strong odor is present.

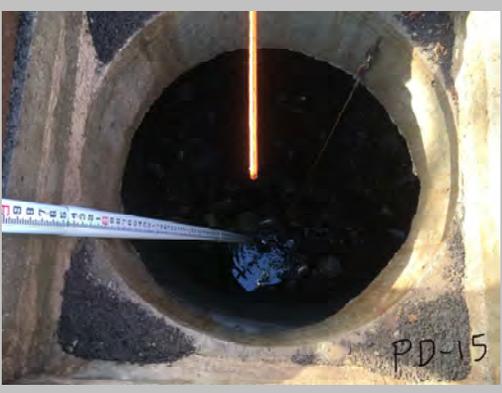
PD-15 West, 11/05/2019

Inspector Name(s): Mark Bruns		Weather Conditions: 34 Degrees, Partly Cloudy				
Inspection Date: 11/05/2019		Location: 60th & Silverbrook, PD-15 West				
Type of Inspection	Drainage System Feature	Problem	Conditions to Check For	Recommended Action	Maintenance Needed (Yes/No)	Comments
Inspections are performed in accordance with the maintenance agreement or owners recommendation	Settling Chamber	Sediment accumulation	Sediment capacity reached (varies depending on the model, see attached table)	Sediment should be removed using vactor truck	<input type="radio"/> N/A <input type="radio"/> Yes <input checked="" type="radio"/> No	Less than 0.25 feet of sediment.
	Settling Chamber	Trash and floatable debris accumulation	Excessive trash and floatable debris accumulation.	Remove trash or other floatable debris.	<input type="radio"/> N/A <input checked="" type="radio"/> Yes <input type="radio"/> No	Floating debris is present.

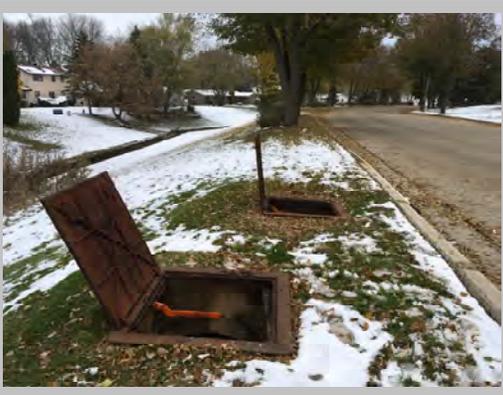
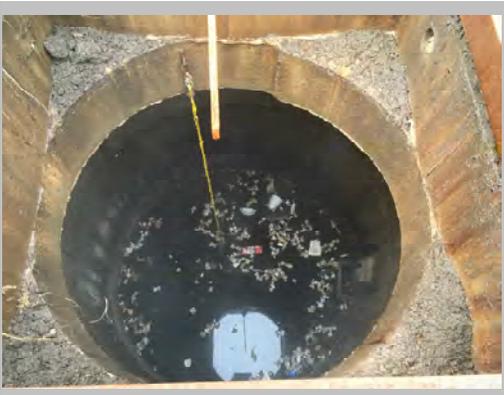
PD-16 Northeast; 11/01/2019

Inspector Name(s): Mark Bruns		Weather Conditions: 32 Degrees, Cloudy				
Inspection Date: 11/01/2019		Location: 55th & Beaver Creek Pkwy; PD-16 Northeast				
Type of Inspection	Drainage System Feature	Problem	Conditions to Check For	Recommended Action	Maintenance Needed (Yes/No)	Comments
Inspections are performed in accordance with the maintenance agreement or owners recommendation	Settling Chamber	Sediment accumulation	Sediment capacity reached (varies depending on the model, see attached table)	Sediment should be removed using vactor truck	<input type="radio"/> N/A <input type="radio"/> Yes <input checked="" type="radio"/> No	0.3 feet of sediment.
	Settling Chamber	Trash and floatable debris accumulation	Excessive trash and floatable debris accumulation.	Remove trash or other floatable debris.	<input type="radio"/> N/A <input checked="" type="radio"/> Yes <input type="radio"/> No	Some floating debris is present.

Comments: Boom is grey in color. No sheen or unusual odor is present.

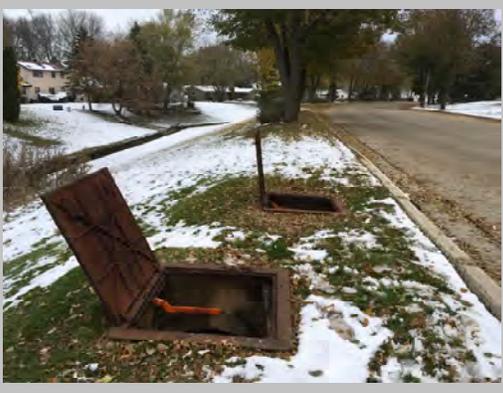
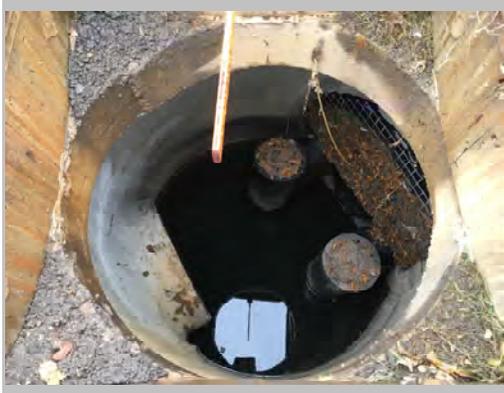
PD-16 Southwest; 11/01/2019

Comments: Boom is not visible. No unusual odor or floatable debris is present.
